**SURFACE INSPECTION
COMPLIANCE REPORT**Date of Inspection: March 21, 2001Case Serial No.: UTU-075888Operator: Resource Design Solution (Joe Dunlop)Project Description: Mining GraniteLegal Description: SE¼ Sec 35, T. 12 S., R. 7 W.Field Office: FillmoreInspector: Larry GarahanaREPORT NARRATIVE (REFERENCE STIPULATIONS BY NUMBER OR TITLE)

UTU-075888 Resource Design Solutionsd

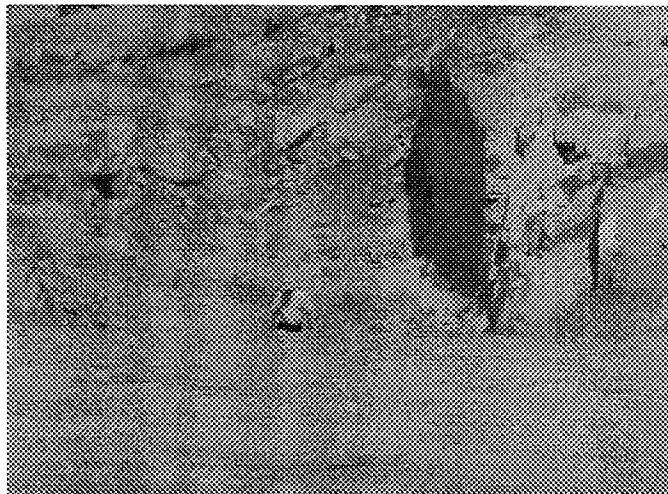
Facing ~ northwest

Photo shows: Area where RDS has removed material and was actively mining.

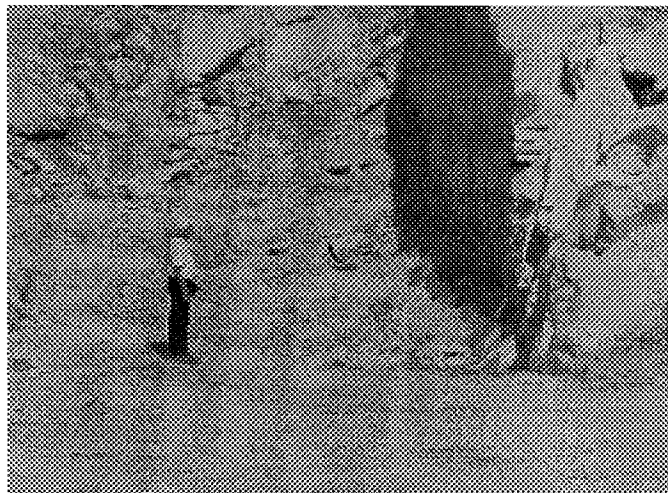
Facing ~north

Photo shows: Quarry wall where RDS has removed material (Tom for scale)

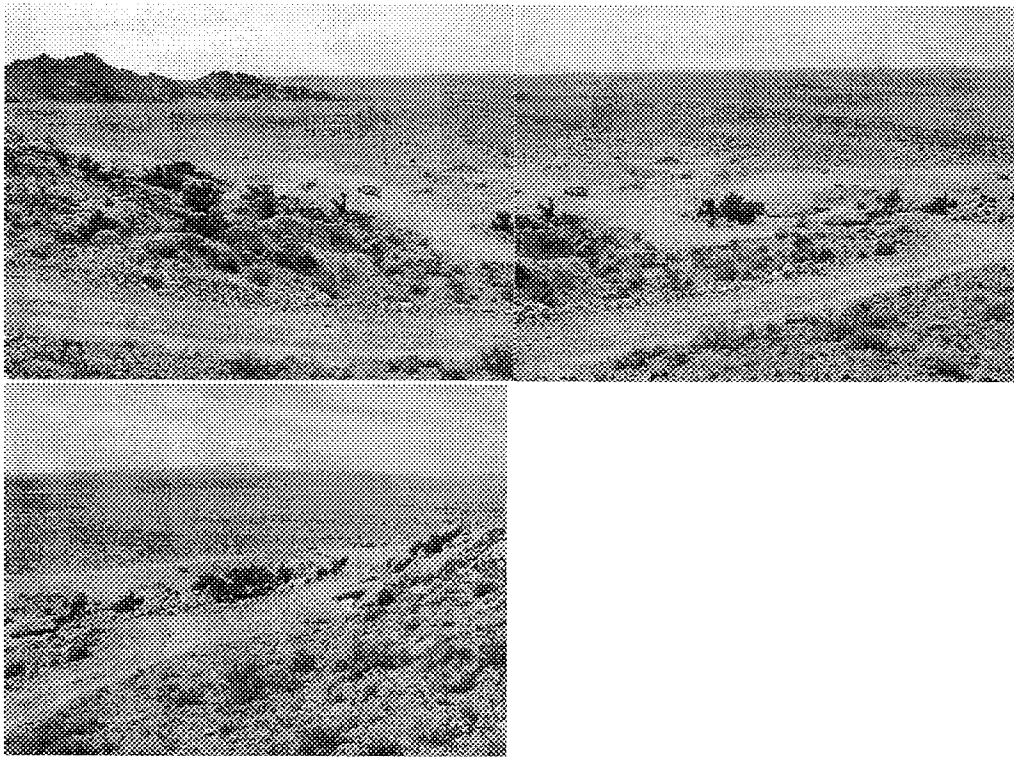
Facing approximately south

This inspection I was accompanied by Tom Munson (DOGM), and we were at this site to confirm reclamation had not been completed, and to discuss what actions we may proceed with next. Upon arrival I noticed there had been no further work conducted since my inspection on March 7, 2001.

Photo shows: Area that RDS agreed to reclaim in order to remain under five acres.

I suggest we send RDS a letter of noncompliance, for their violations of the 3809 regs.
